Technical Report REMR-OM-17  
September 1995

# REMR Management Systems—Navigation Structures, Condition Rating Procedures for Tainter Dam and Lock Gates

*by Lowell Greimann, James Stecker, and Mike Nop  
Engineering Research Institute*

Engineering Research Institute  
Iowa State University  
Ames, Iowa 50011

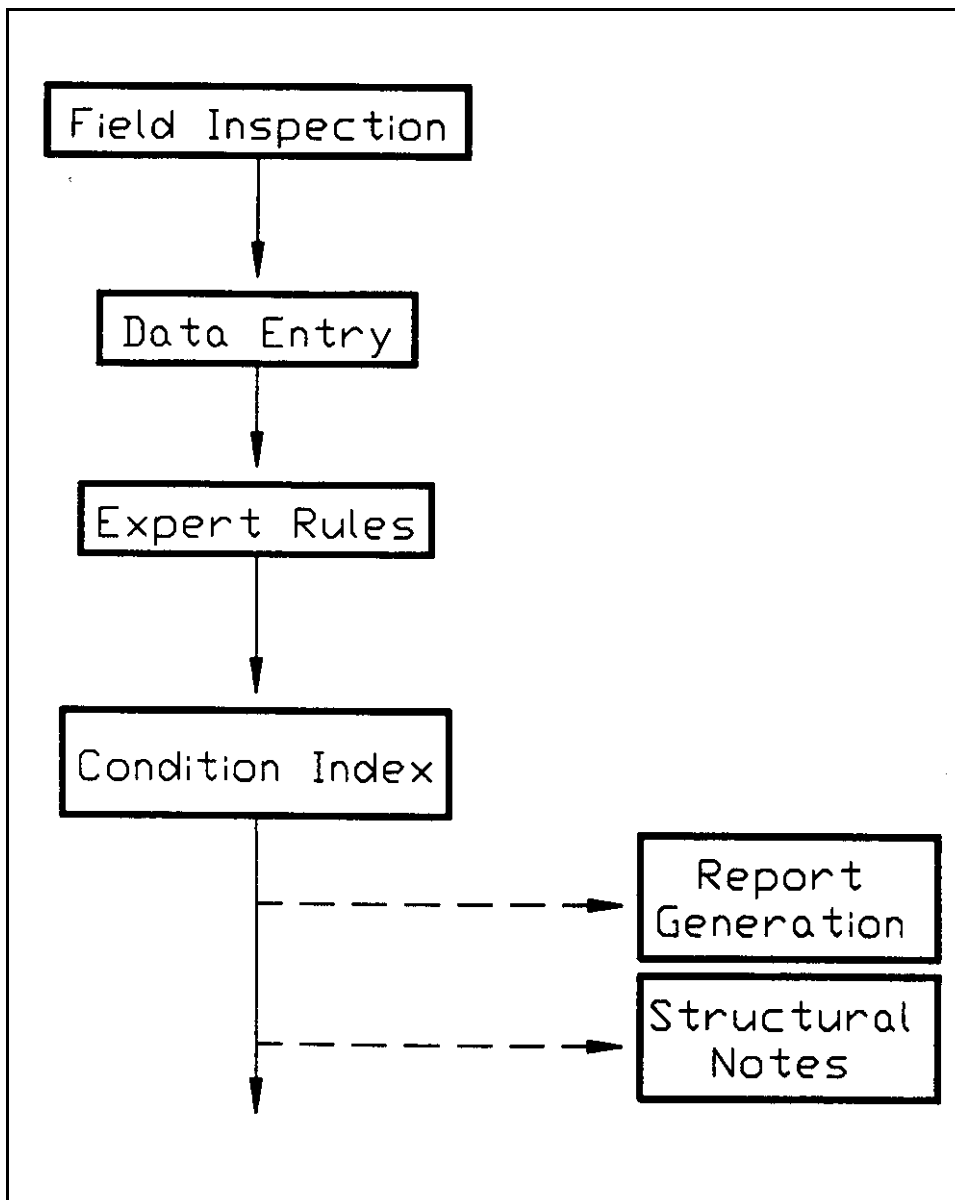
Figure 1. Inspection and rating procedure.

Figure 1 illustrates the inspection and rating procedure. The field inspection is the means of gathering consistent data for any particular tainter dam or lock gate. The first two pages of the inspection form are used to record descriptive data, such as the type and location of the gate, general component information, and maintenance history. Additional pages provide space for field measurement data, such as anchorage assembly deterioration, corrosion, and cracks. The field measurement data is representative of the current state of the structure. All the information collected on the inspection form is entered into a data file on a microcomputer that performs all the calculations necessary to rate the gate.

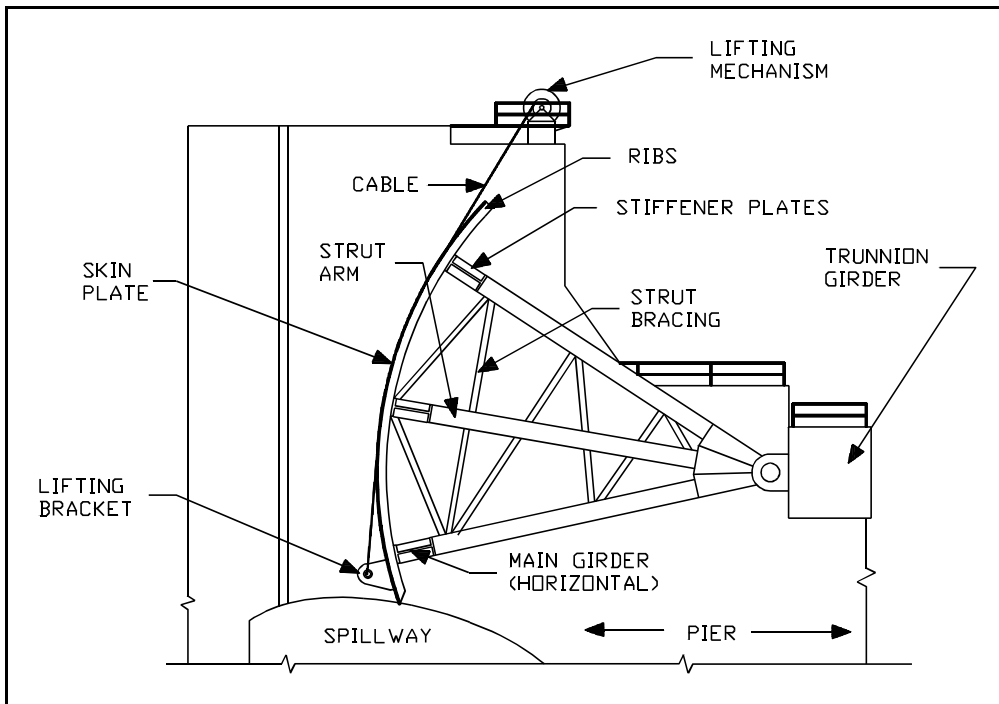
Figure 3. Side view of tainter gate.

**Skin plate:** An upstream skin plate is welded or riveted to the ribs to provide stiffness to the structure (Figures 3, 4, and 5). It dams the water and transfers load to the ribs. A downstream skin plate also may be present.

**Ribs:** The ribs, usually tees, are welded or riveted to the main girders. The ribs transfer load from the skin plate to the main girders (Figures 3, 4, and 5).

**Main girders:** The main girders can be either horizontally or vertically positioned. They span the width or height of the gate and transfer load from the skin plate and ribs to the strut arms (Figures 3, 4, and 5).

**Strut arms:** Strut arms are the steel girders that transfer load from the main girders to the trunnion assembly (Figures 3, 4, and 6). Some strut arms are parallel to the pier face and some slope toward the center of the gate from the trunnion, as shown in the figures.

**Trunnion girder:** The concrete or steel trunnion girder is anchored into the pier or lockwall (Figures 3 and 6). It transfers load from the trunnion yoke to the pier or lockwall.

**Lifting chain or cable:** The lifting chain or cable connects the operating machinery with the gate (Figure 3). It moves the gate between its open and closed positions.

**Lifting bracket:** The lifting brackets are located near the bottom of the gate on either the upstream or downstream side of the skin plate. They connect the chain or cable to the gate structure (Figures 3 and 4).

**Strut bracing:** The strut bracing acts as an internal truss framework (Figure 3). The specific arrangement of the members varies from gate to gate.

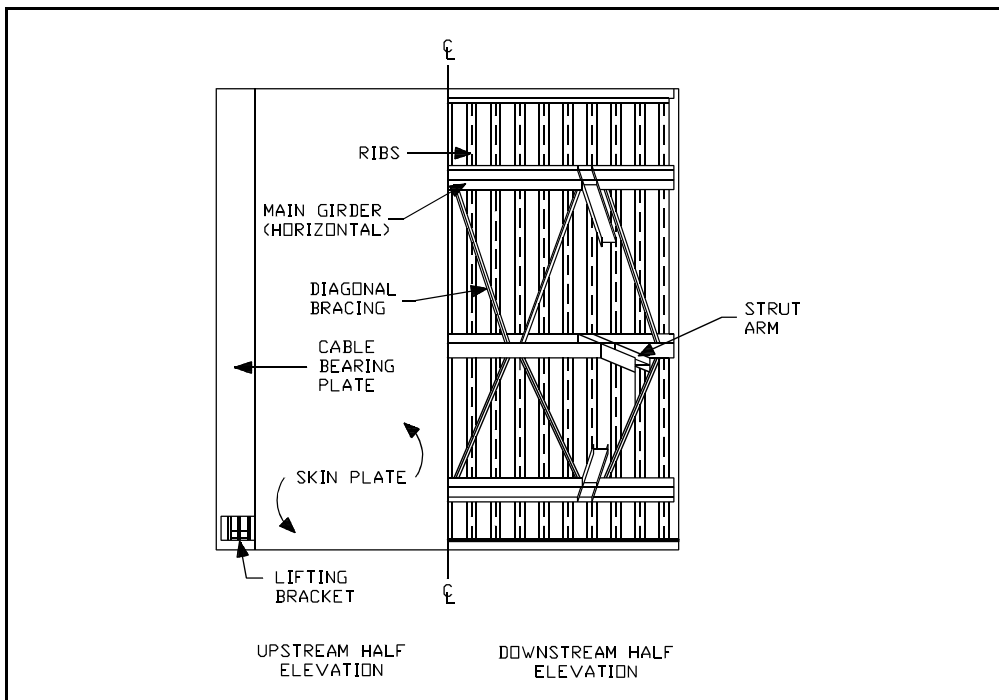
Figure 4. Elevation view of tainter gate.

**Cable or chain bearing plate:** A bearing plate is a thickened or doubled strip of the skin plate or back-to-back channels located on the upstream side (Figure 4). It reduces the wear on the skin plate caused by the sliding contact of the cable or chain as the gate is moved.

**Diagonal bracing:** Diagonal bracing is commonly used across the downstream flanges of the main girders (Figure 4). It aids in the field erection of the gate and adds to its rigidity.

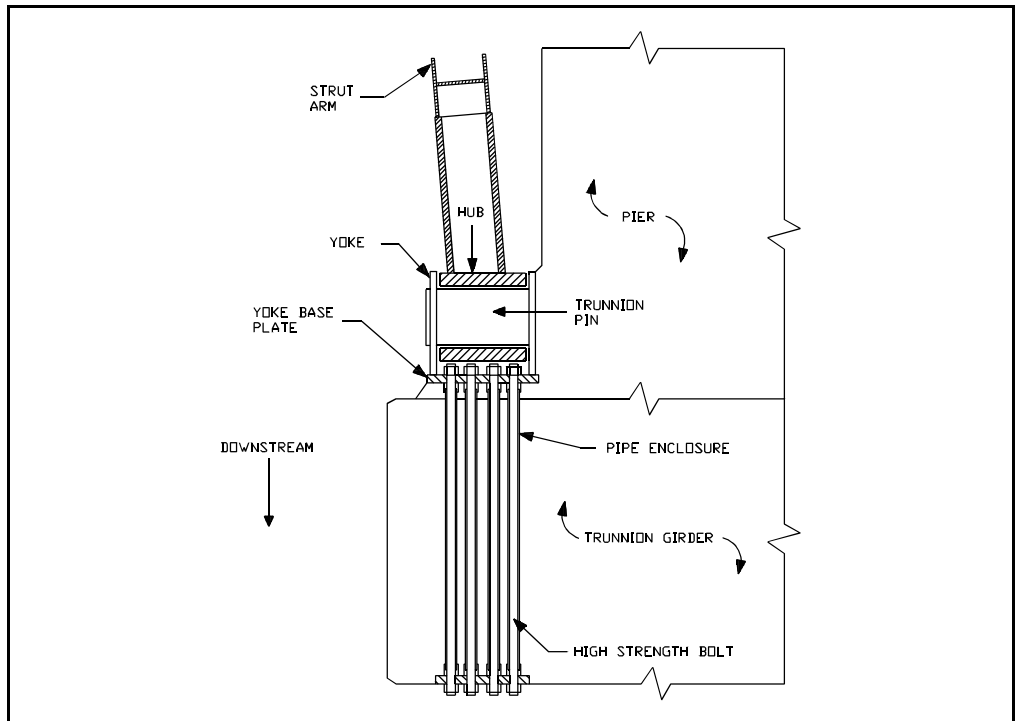
**Figure 6. Example trunnion assembly detail (individual projects differ considerably).**

**Trunnion assembly:** The trunnion assembly consists of a trunnion hub with bronze bushing and heavy flanges, a trunnion yoke, and a trunnion pin (Figure 6). The trunnion assembly transfers load from the strut arms to the trunnion girder.

**Trunnion hub:** The trunnion hub consists of a cylindrical plate and bushing which encompass the hinge pin and transmit load from the strut arms to the trunnion yoke (Figure 6). The flanges align the strut.

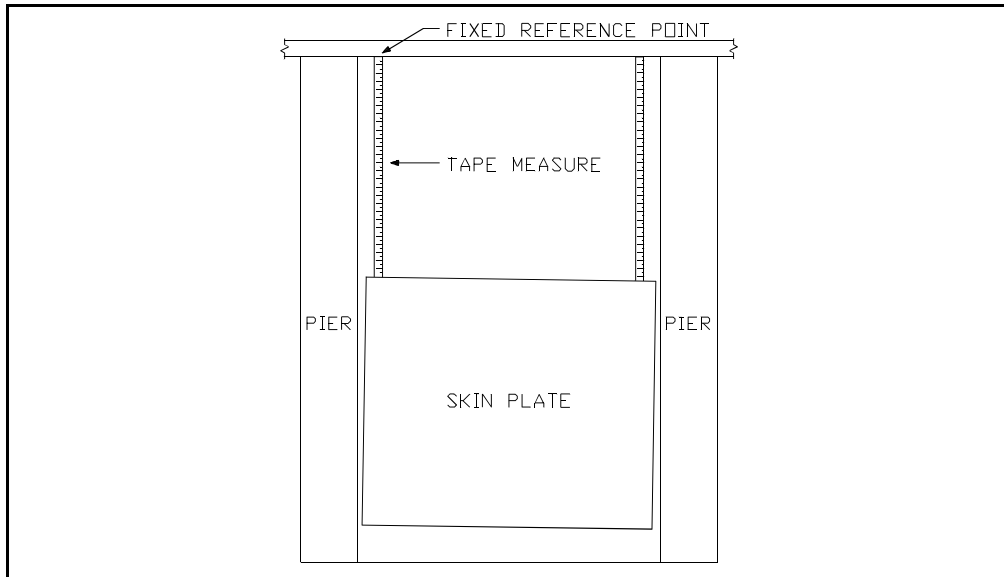
**MISALIGNMENT:** Measurements are recorded with the gate in the closed and 2 ft. open positions and then again in the closed position. Measurements can be made by attaching a tape measure to the skin plate on each side of the gate and recording the distance from a fixed reference point above the gate to the top of the gate (Figure 7). An alternative method of measurement consists of placing an electronic level horizontally along the skin plate and recording the angles (in degrees) at each gate position. (Levels should measure angles to the nearest 0.001 degrees.)

**Figure 7. Misalignment measurement.**

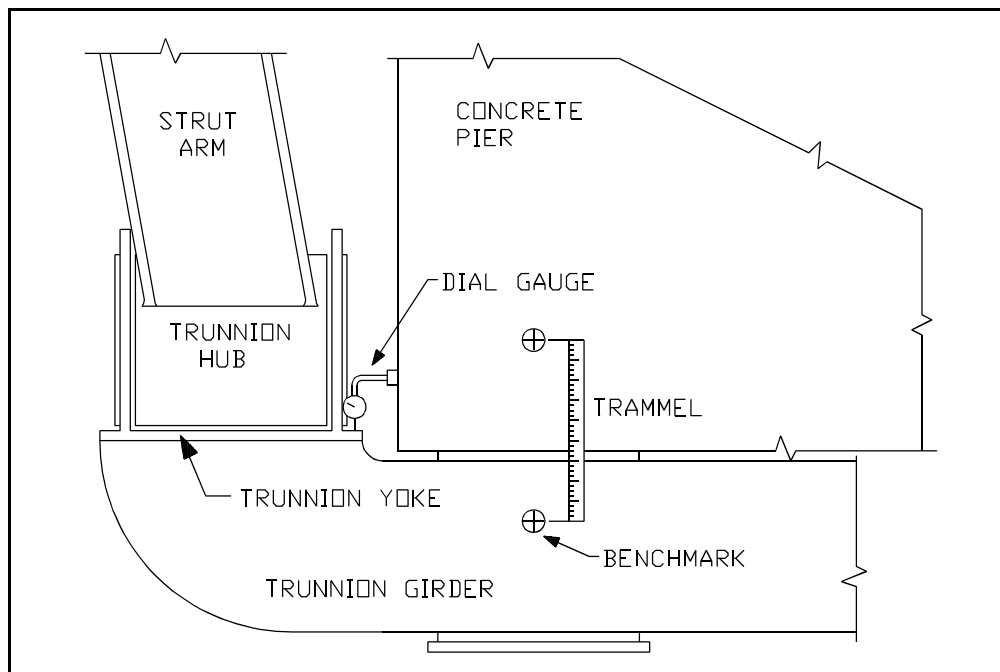
**ANCHORAGE MEASUREMENT:** Measurements of relative movement between the concrete pier and trunnion yoke or girder are taken in the downstream direction (Figure 8). If the inspection is performed under **NORMAL OPERATING CONDITIONS**, dial gauges are used to measure this movement and measurements are taken with the gate in the closed and 2 ft. open positions and then again in the closed position. For tracking relative movement over time, permanent reference points or benchmarks are established on the trunnion girder and on the pier adjacent to the girder. The distance between these points are recorded with the gate in the closed position after the gate has been lifted and reset. A convenient means of doing this is by using a trammel with permanently fixed trammel points for benchmarks. If **BULKHEADED CONDITIONS** exist, dial gauge measurements are taken in the closed position with no head on the gate and with full head on the gate. The term, no head, implies that the water on the upstream face of the gate will be removed by opening the gate. If a tailwater is present on the gate, the upper pool will be equal to the level of the lower pool with no net head. To apply full head or load, lift the bulkhead and flood the gate. Dial gauge measurements should be recorded to 0.001 inch. Trammel measurements between the permanent reference points are taken in the no head condition. Trammel measurements should be recorded as accurately as possible (about 0.0313 in. or 1/32 in.).

**Figure 8. Anchorage measurement.**

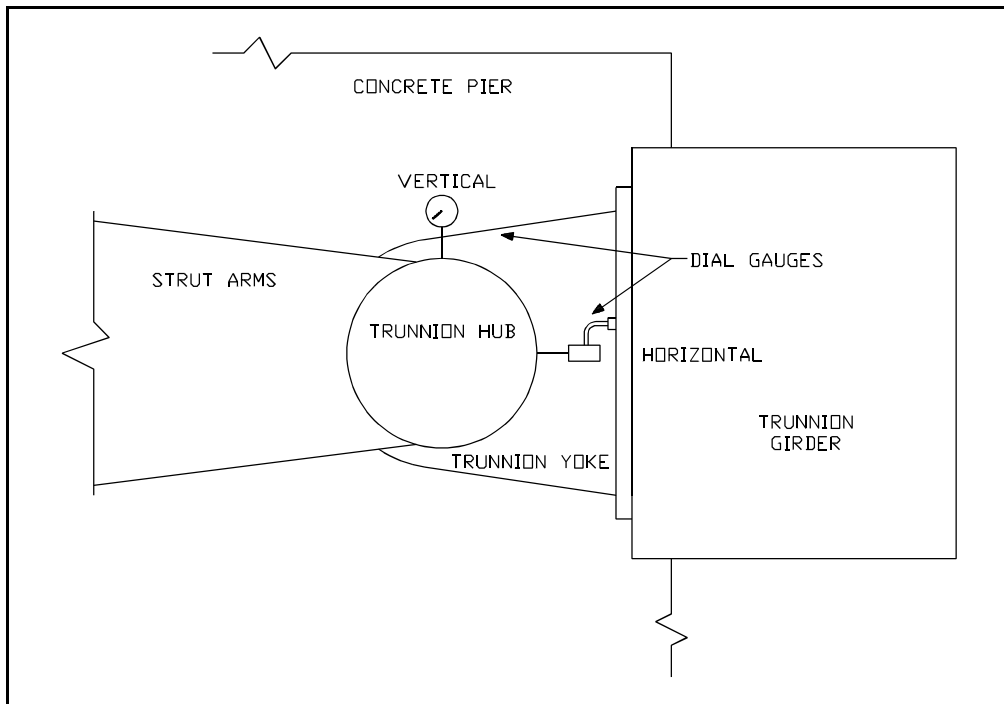
**Figure 9. Trunnion assembly wear measurement: dial gauges.**

**TRUNNION ASSEMBLY WEAR:** Indicate whether the lubrication system is functional. If a unique situation exists, such as a nonlubricated trunnion, NA can be circled. The horizontal and vertical measurements are used to detect motion between the trunnion pin and the bushing. Indicate whether feeler or dial gauges will be used to take the horizontal and vertical measurements. For some gate designs the trunnion pin is exposed and, therefore, it may be possible and simpler to take the horizontal and vertical gap measurements using feeler gauges. Trammel measurements are required.

For an inspection performed under **NORMAL OPERATING CONDITIONS** the horizontal and vertical measurements are made with the gate in the closed and 2 ft. open positions and then again in the closed position. If dial gauges are used to measure the horizontal and vertical movement, it is important that the bearing surface for the dial gauge stem be smooth, with no unevenness, since the trunnion hub rotates. If feeler gauges are used, gap measurements are taken between the pin and bushing in four locations: upstream, downstream, top, and bottom. Horizontal trammel measurements are taken between permanent reference points or benchmarks which have been established in convenient positions on the trunnion hub and yoke. Trammel measurements are recorded in the closed position after the gate has been lifted and reset. Estimate lateral movements and circle correct answer. Gouging occurs when the trunnion hub bears on the trunnion yoke.

The measurements taken in the horizontal,  $X_{HOR}$ , and vertical,  $X_{VER}$ , directions can be made using feeler or dial gauges and trammels (Figures 9, 10, 11). The total motion, no matter what measuring device is used, is calculated by taking the square root of the sum of the squares of the horizontal and vertical movements in each direction:

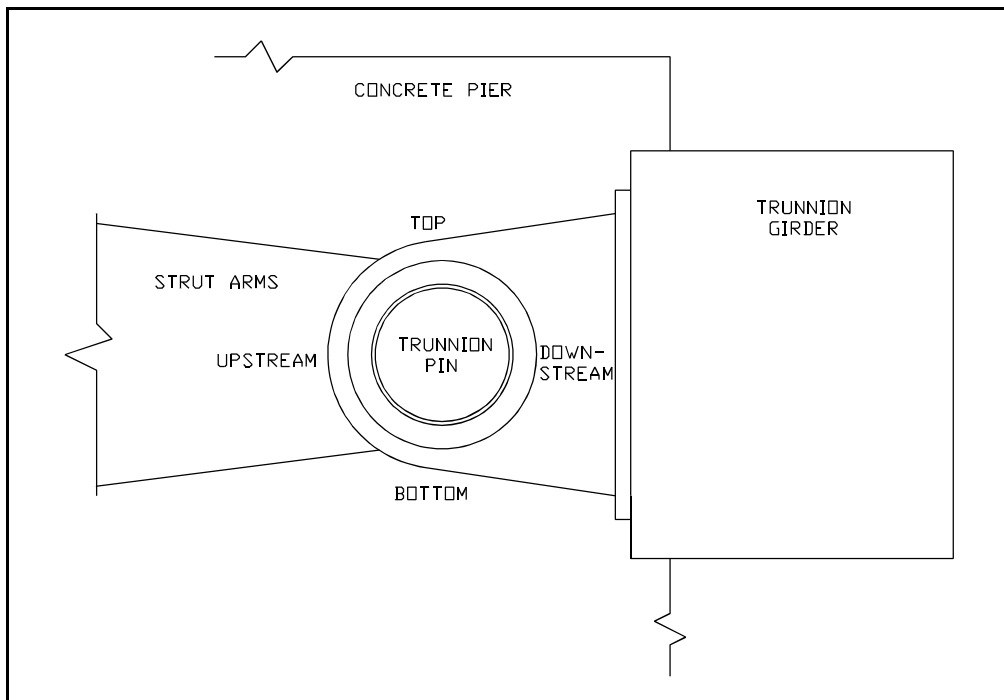
**Figure 10. Trunnion assembly wear measurement: feeler gauges.**

Under **BULKHEADED CONDITIONS** the measurements will be recorded with the gate in the closed position when no head or load is present on the gate and when full head exists. If feeler gauges are used, gap measurements shall be taken between the pin and bushing in the same locations as under **NORMAL OPERATING CONDITIONS**. If dial gauges are used, no special precautions are required to ensure a smooth bearing surface for the stem because the trunnion hub will not rotate. Horizontal trammel measurements are also taken between the permanent reference points for the no head condition.

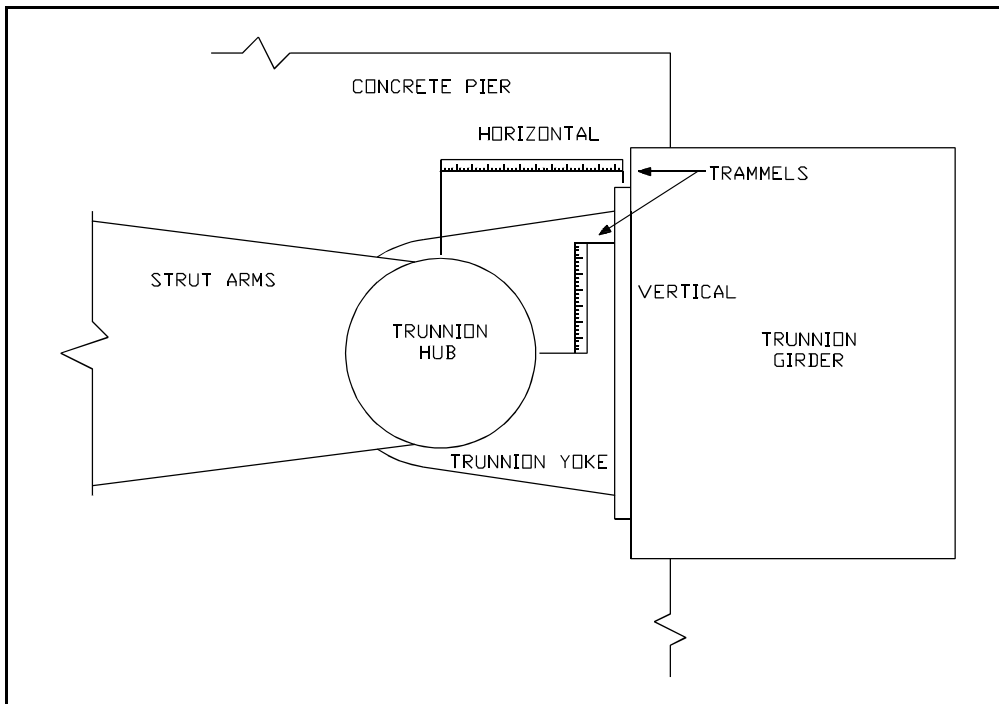
**Figure 11. Trunnion assembly wear measurement: trammels.**

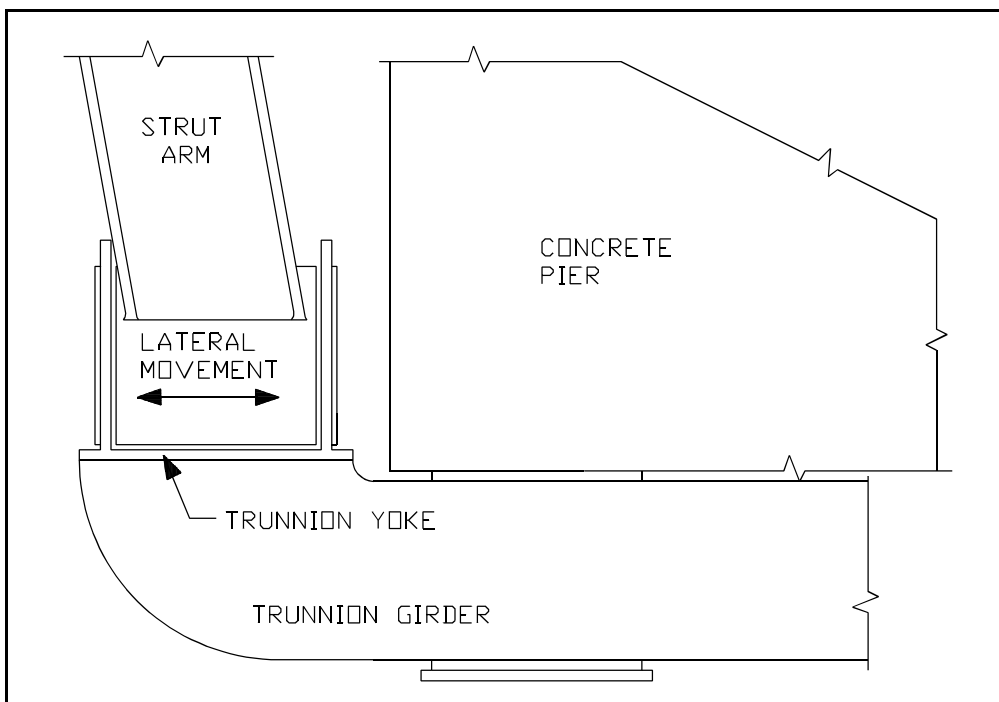
**Figure 12. Trunnion assembly wear: lateral movement.**

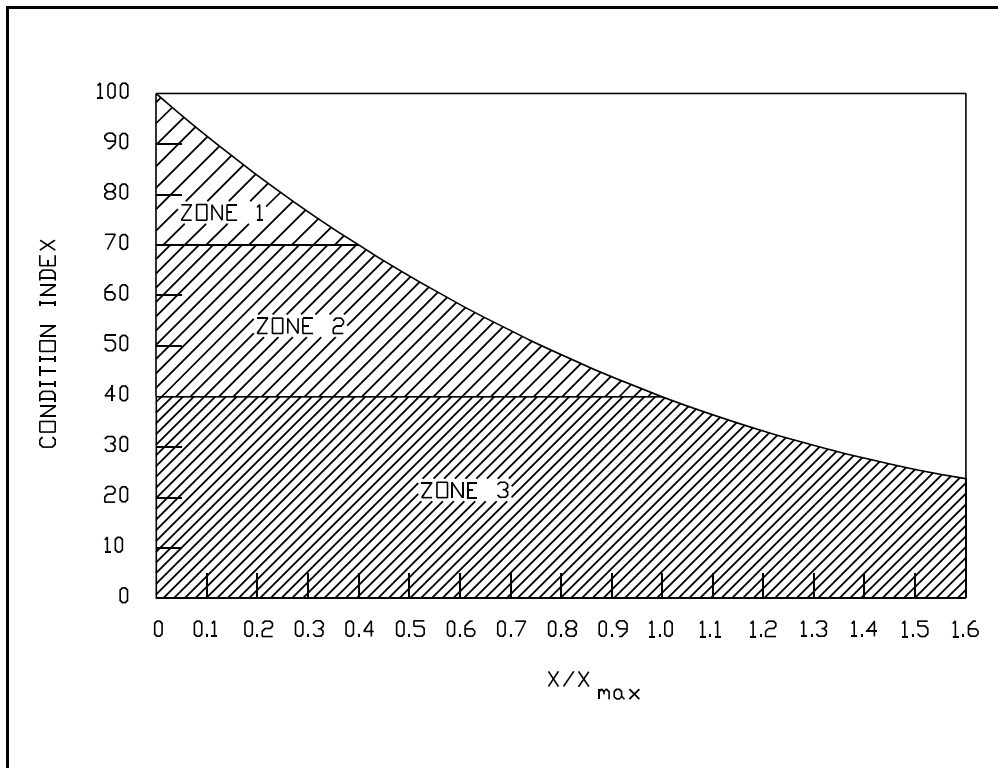
**Figure 13. Condition index related to  $X/X_{max}$ .**

where  $X_{max}$  is some limiting value of  $X$ . The CI zones given in Table 2 define  $X_{max}$  as the point at which the CI is 40, that is, the dividing point between Zones 2 and 3. In other words, the experts have chosen the limiting value  $X_{max}$  to be the point at which a tainter gate requires immediate repair or, at least, a more detailed inspection. Figure 13 illustrates the equation and zones from Table 2.

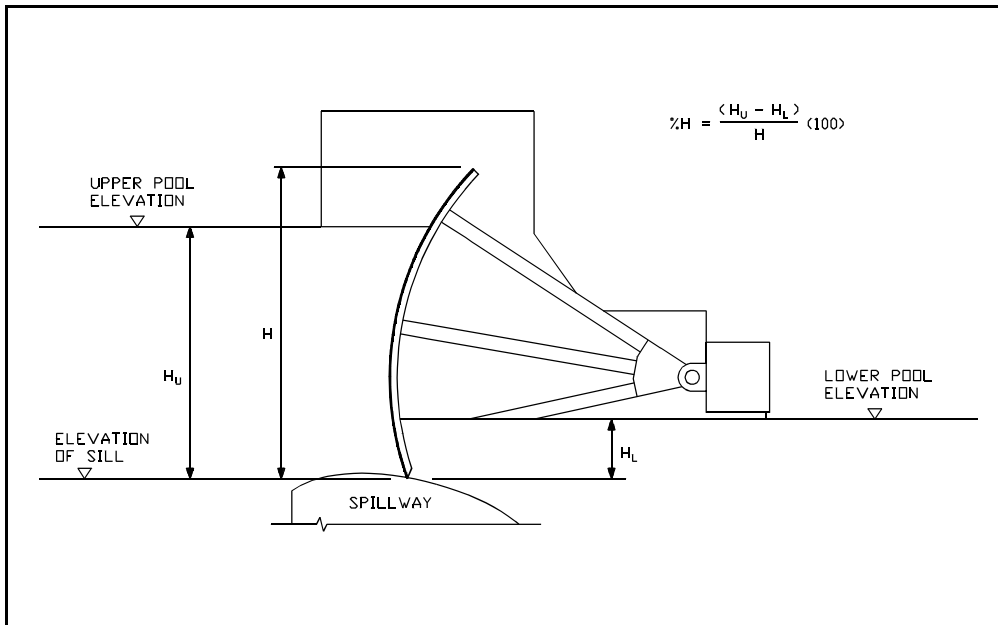
Figure 14. Percent head with tailwater.

*Bulkheaded conditions:* Dial gauges are used to measure short-term movement under bulkheaded conditions. This displacement,  $X_s$ , is the difference between the full-head and no-head readings. The limiting value is dependent upon the percent of head present on the gate, %H, which is equal to the head applied to the gate when the bulkhead is removed, expressed as a percent of gate height, H (Figures 14 and 15). For a rigid anchorage, the limiting values are, if there is less than 20 percent head on the gate,

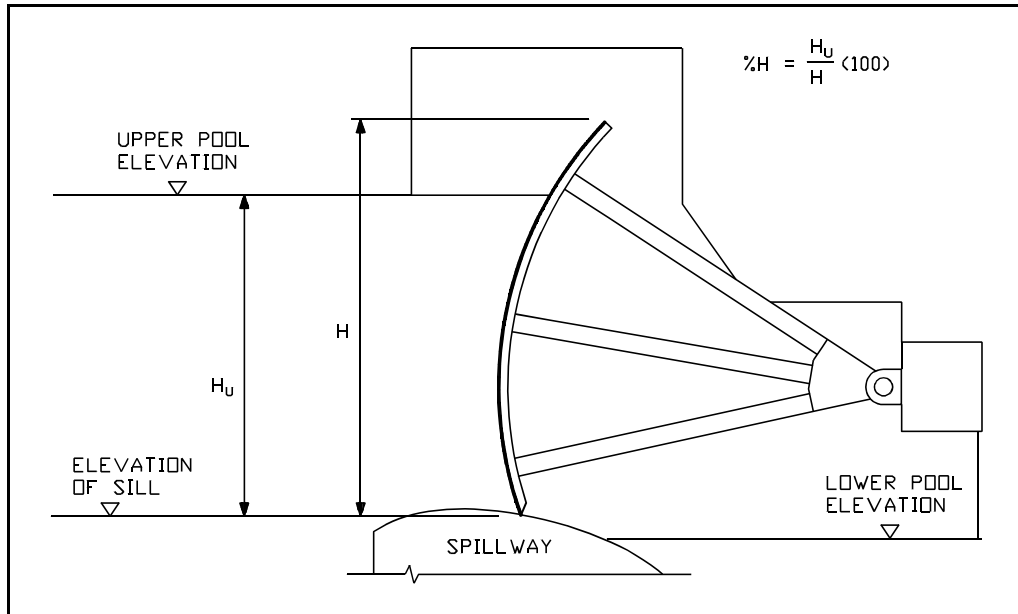
Figure 15. Percent head without tailwater.

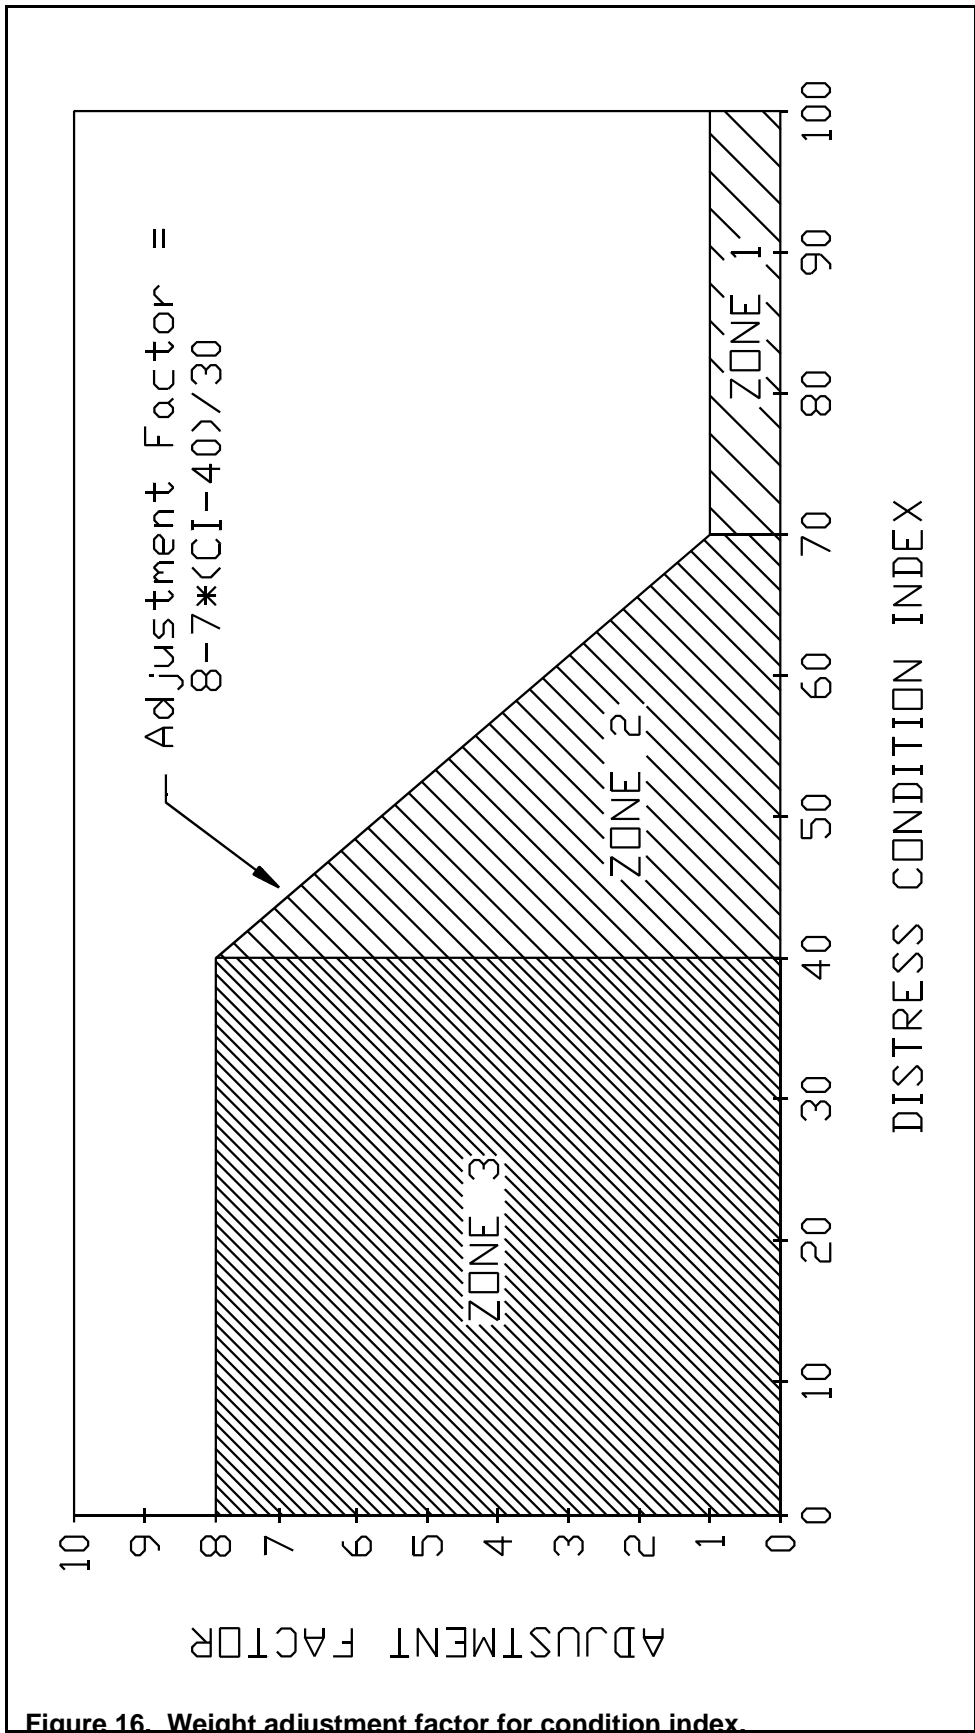
Figure 16. Weight adjustment factor for condition index.

Previous work done by the ISU project team has established that the relative importance of a distress should be greater as the distress becomes more severe. This concept is established by introducing a variable adjustment factor, which will increase the distress weighting factor  $w_i$  as its CI approaches Zone 3. The adjustment factor plotted in Figure 16 has a maximum value of eight; that is, if a distress has a CI that is less than 40, its importance increases eight times.

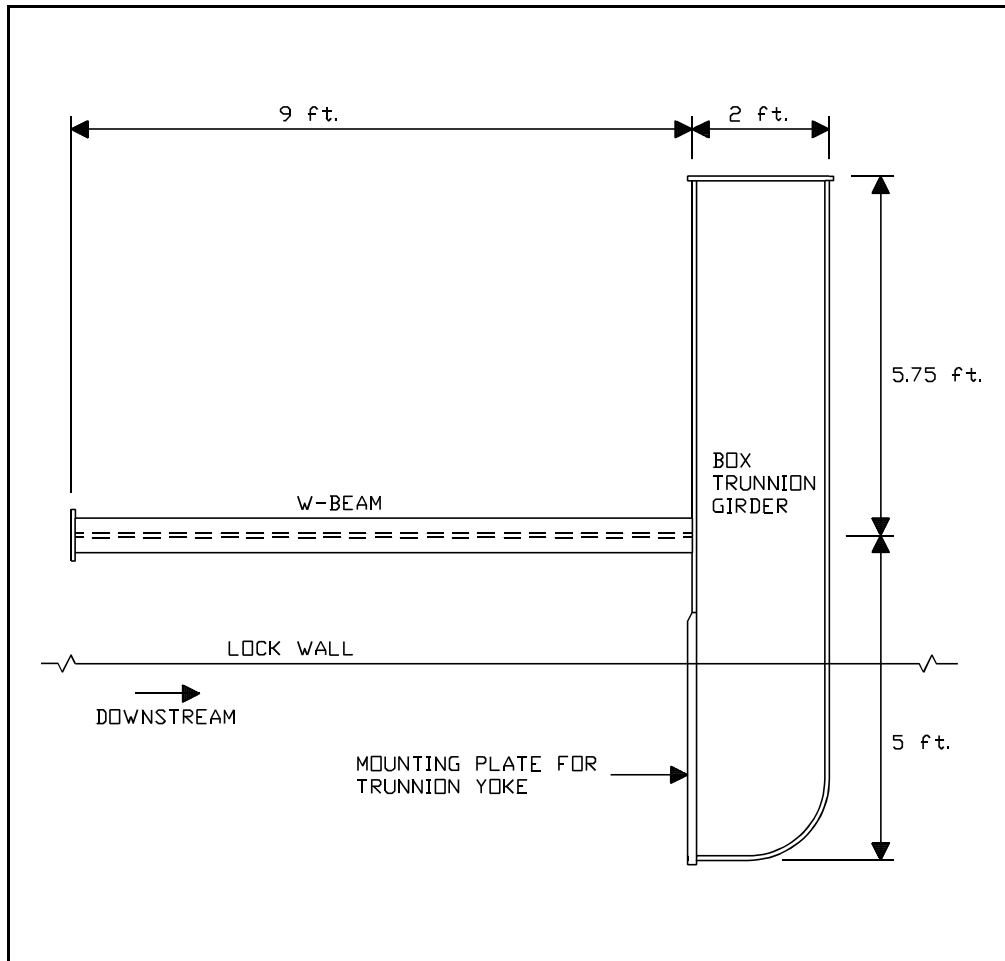
**Figure 17. Flexible anchorage at lower St. Anthony Falls.**

0.065 in. using Eq. 3.16 with an embedment length,  $L$ , of 9 ft, which is the length of the W-beam (Figure 17). The movement measured during the inspection was 0.013 in. The calculated CI would more closely approximate the expert average if the rule, which is based on an allowable axial deformation, included the deformation of the 5-ft box trunnion girder. However, the authors feel that the anchorage configuration is unique, and therefore an analysis is not warranted. Long term movements could not be determined because only current readings were available. The accuracy of trammel measurements may not be sufficient.

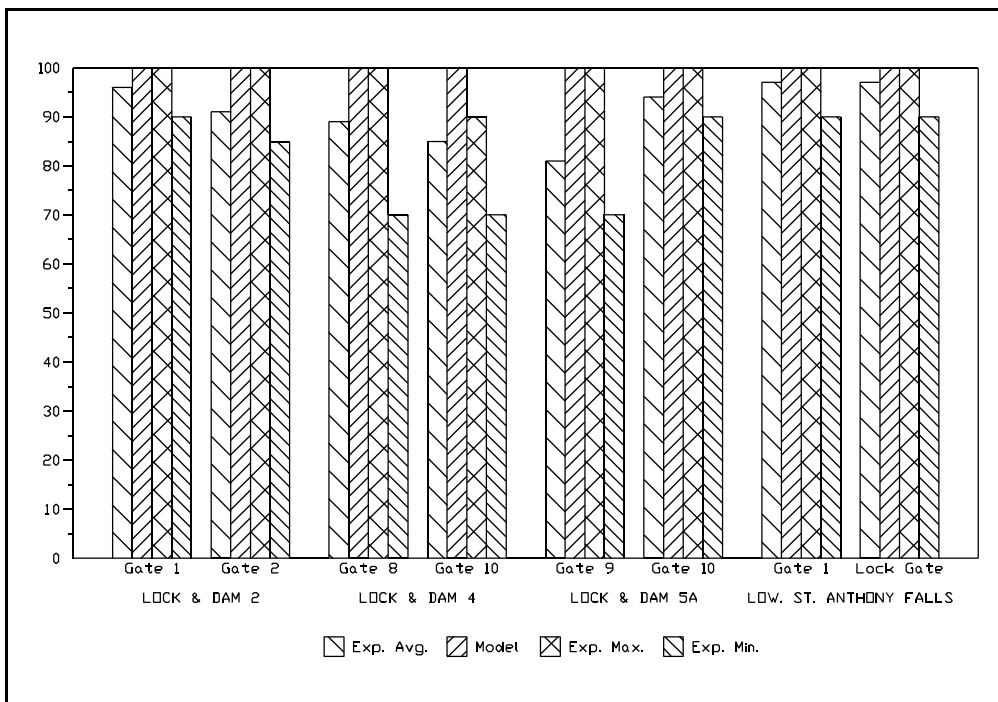
Figure 18. Noise, jumping, and vibration.

## Noise, Jumping, and Vibration (Figure 18)

Because no abnormal noise, jumping, or vibration was recorded, the calculated CI values were 100. Although no abnormal distress information was recorded, the experts did not give this distress a perfect rating. Normal vibration was observed on Gate 2 at Lock and Dam (L&D) 2 and on Gate 10 at L&D 4; also, normal noise and vibration were observed on Gate 9 at L&D 5A. The experts may have rated this distress lower than 100, particularly on the gates where normal occurrences were observed, because they did not feel that a distress CI should be 100 if the structure was not new. This phenomena is consistent with what experts have felt about previous structures. Gate 8 at L&D 4 has an expert average rating of 89, which is unexplainably low because no normal or abnormal occurrences of this distress were recorded.

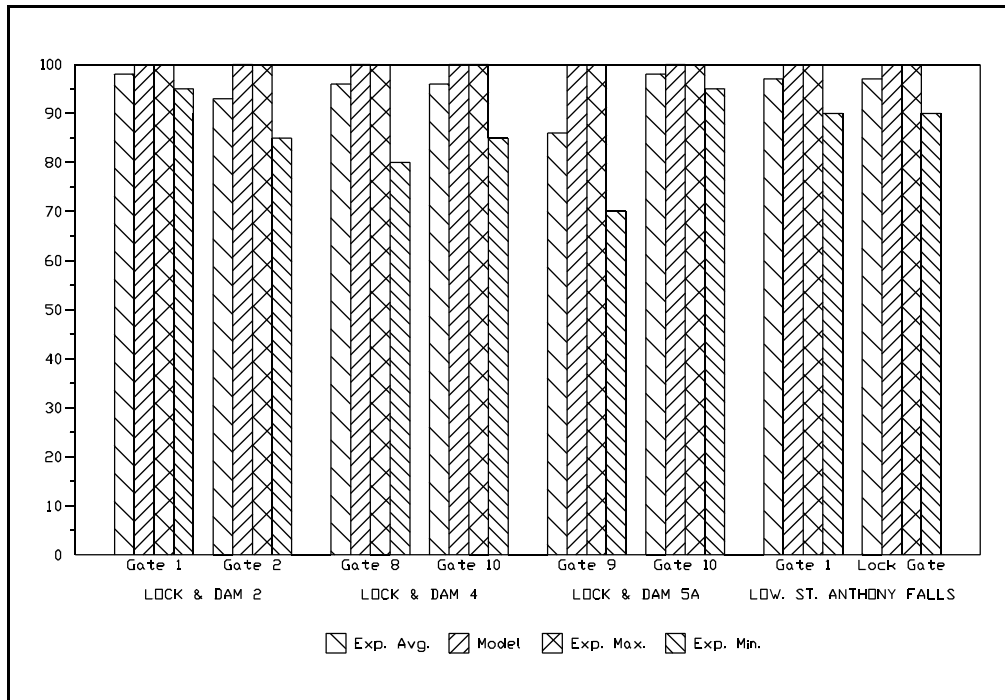
**Figure 19. Vibration with flow summary.**

## Vibration With Flow (Figure 19)

Again the calculated CIs for each gate were 100 and the experts rated the gate lower. Level 1 gate vibration was experienced on Gate 2 at L&D 2 and on Gate 9 at L&D 5A, which explains the lower-than-normal expert average rating for these two gates. However, the vibration disappeared when the position of the gates was adjusted and, therefore, the calculated CI was 100.

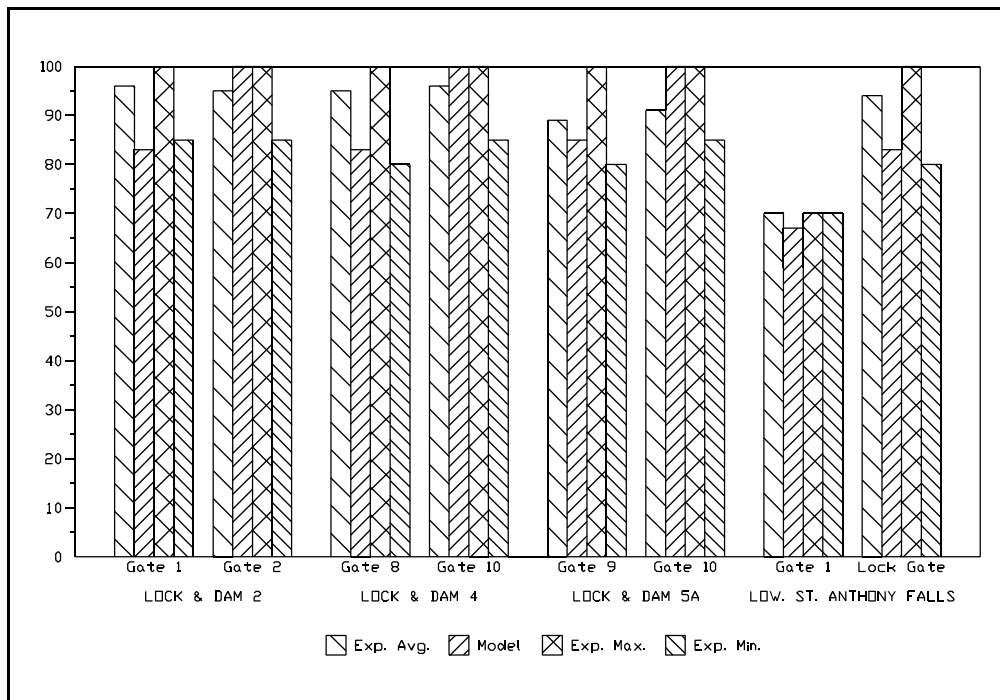
**Figure 20. Anchorage assembly deterioration.**

## Anchorage Assembly Deterioration (Figure 20)

The calculated anchorage assembly CIs closely approximated the expert averages, except for Gate 1 at L&D 2, Gate 8 at L&D 4, and the lock gate at Lower St. Anthony Falls. Movements of 0.001 in. were recorded for Gates 1 and 8, which result in a calculated CI of 83. The experts assigned a limiting  $X_{max}$  value of 0.005 in. for rigid anchorage motion under normal operating conditions. However, the higher CIs assigned by the experts do not support the appropriateness of this limiting value, and suggest that  $X_{max}$  should be increased. Nevertheless, the authors feel that the movement is significant, especially because the load variation on the gate is small under a normal operating condition, and that the calculated CI is appropriate. The calculated CI for the lock gate at Lower St. Anthony Falls was 11 points lower than the expert average. The limiting value for flexible anchorage movement is

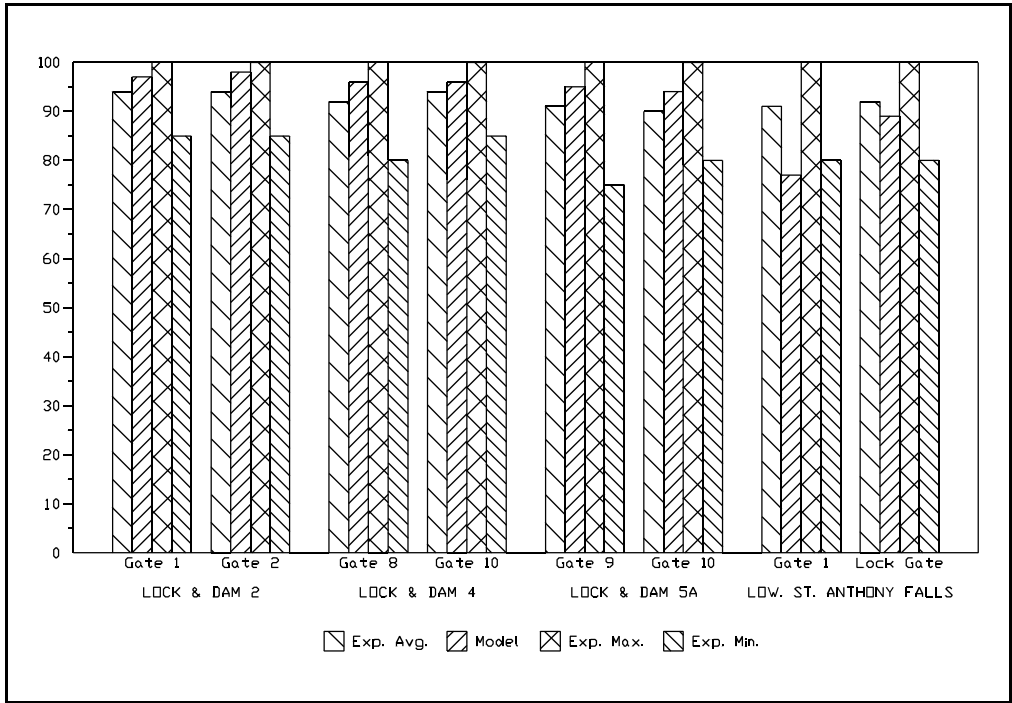
Figure 21. Trunnion assembly wear.

## Trunnion Assembly Wear (Figure 21)

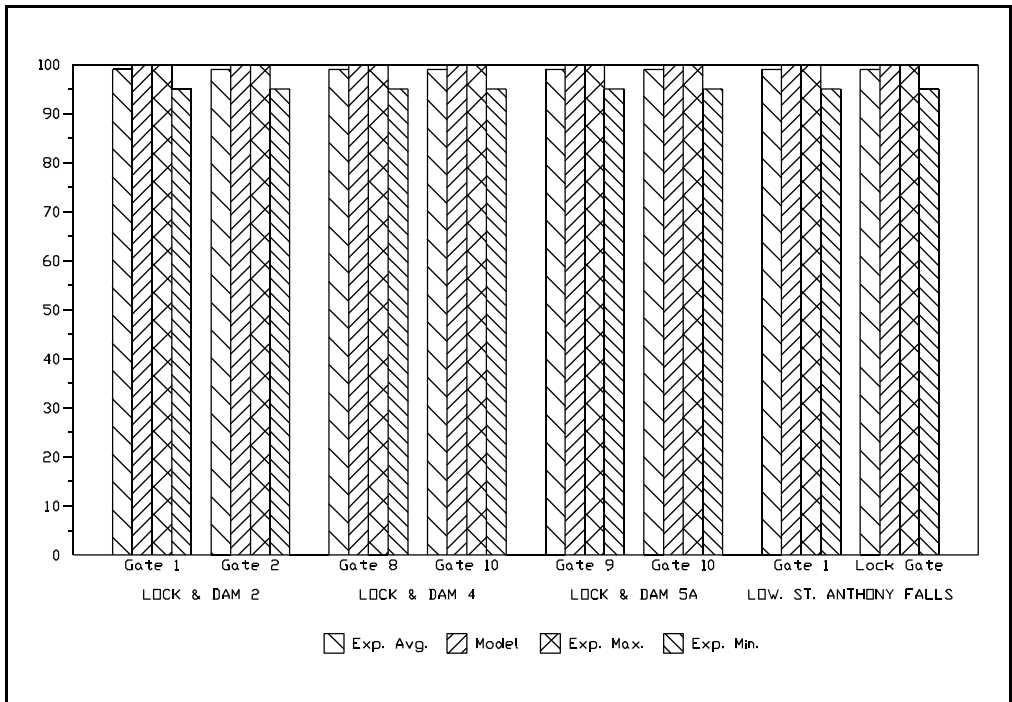
Figure 22. Cracks.

## Cracks (Figure 22)

No cracks were recorded on any gate, resulting in a calculated CI of 100 for the crack distress on each gate. Similar to the noise, jumping, and vibration distress, though, the experts rated the gates slightly lower than 100.

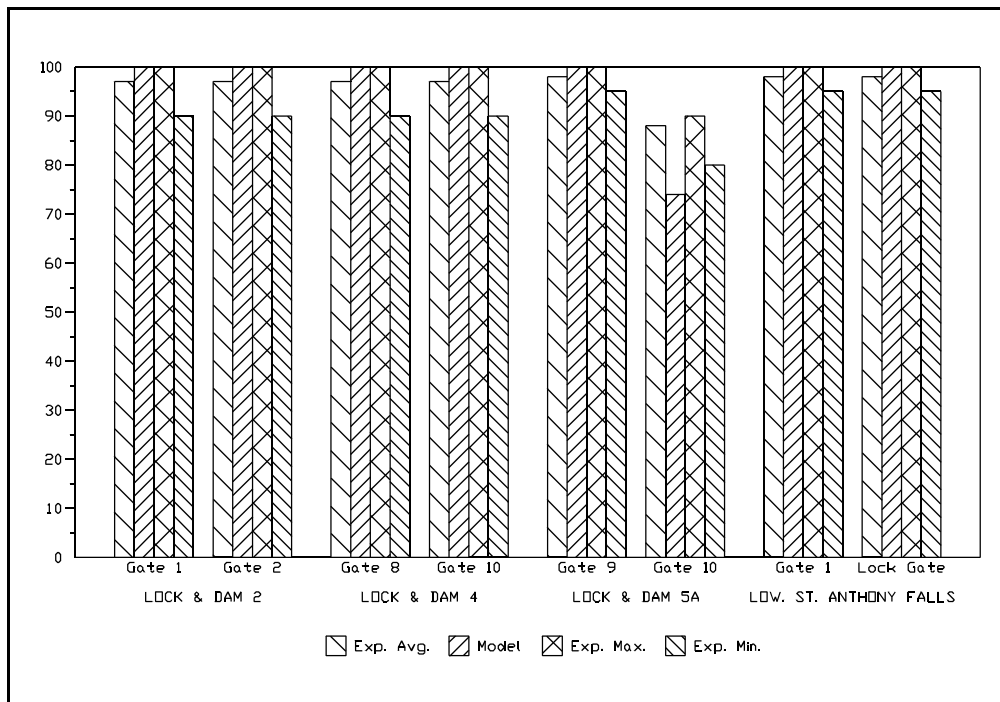
Figure 23. Dents.

## Dents (Figure 23)

The only dents recorded in the field test (three on the skin plate and one on the ribs) were on Gate 10 at Lock and Dam 5A. The calculated CI describing the dent condition was 14 points lower than the expert average for this gate. This calculated CI was controlled by the rib dent; however, the CI calculated for the skin dents was only two points higher at 76. As future inspections are performed, it may be necessary to increase the value of  $X_{max}$  to better reflect the condition of a gate. The more conservative  $X_{max}$  is appropriate at this time.

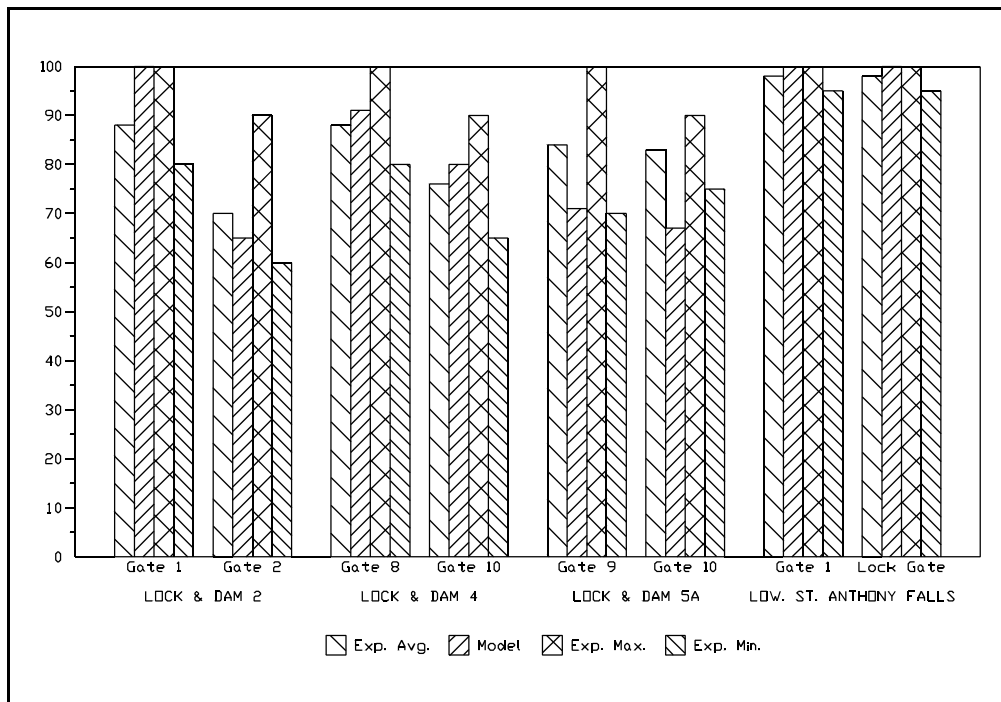
Figure 24. Corrosion/erosion.

## Corrosion/Erosion (Figure 24)

No corrosion or erosion was recorded on Gate 1 at L&D 2 and the gates at Lower St. Anthony Falls. The expert average for Gate 1 at L&D 2 cannot be accounted for by the authors. Strut arm corrosion was the controlling CI for Gate 10 at L&D 4 and the gates at L&D 5A. The calculated CI for Gate 10 at L&D 4 compared well with the expert average. The gates at L&D 5A, however, had calculated CIs that were substantially lower than the expert average. The calculated CI values for Gate 2 at L&D 2 and Gate 8 at L&D 4 correspond relatively well with the expert averages. The corrosion was recorded on the inspection form using primarily the percentage area method.

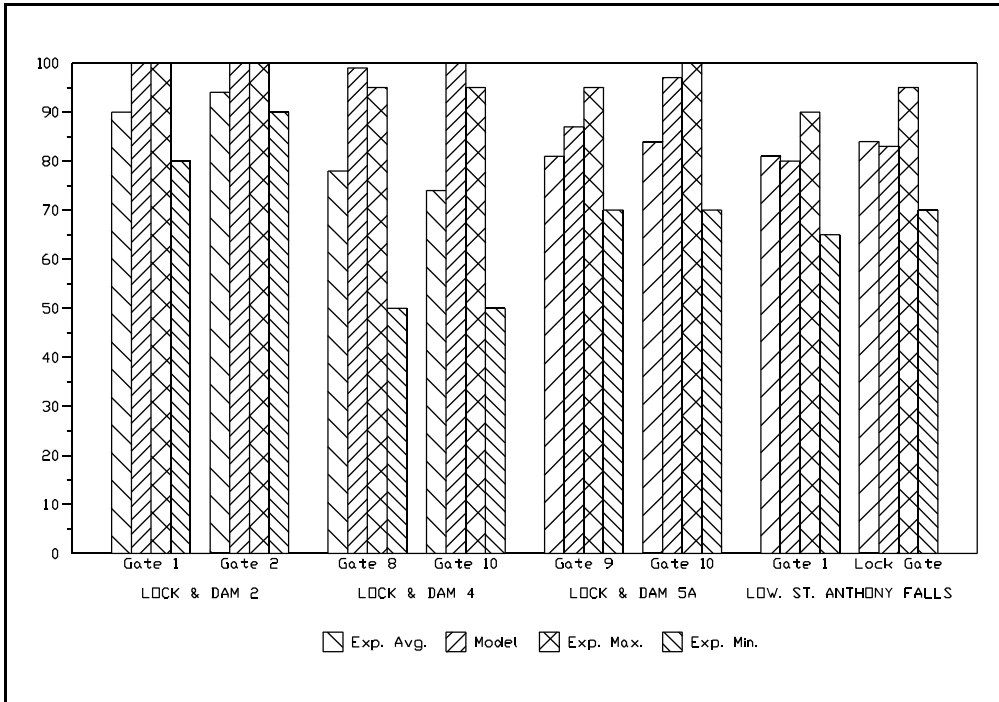
Figure 25. Leaks.

The following bar charts (Figures 18 to 25) present the experts' subjective CI versus the CI calculated by Chapter 3 rules for the distresses associated with tainter dam and lock gates. Each graph is for an individual distress. Within each group of data are four columns of data that represent

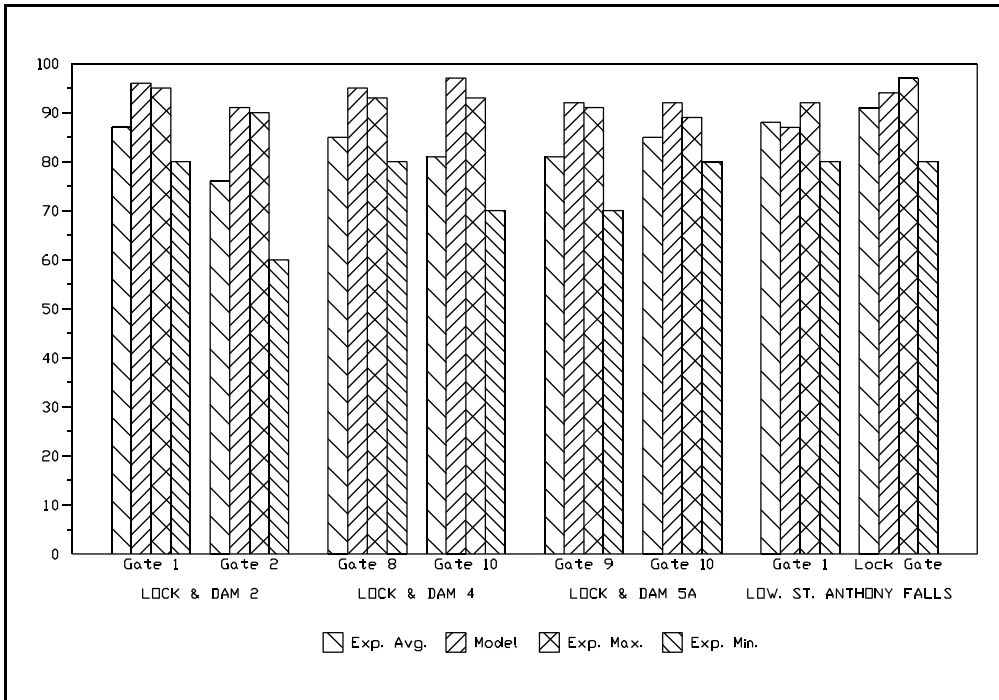
Figure 26. Overall ratings for the gates.

The results of a comparison between the expert rating and the calculated values for each distress are summarized below. In addition, there is a comparison for the overall CI of each gate (Figure 26).

## Overall Gate Ratings (Figure 26)

The overall gate ratings from the calculated model tended to track higher than the expert average, except for Gate 1 at Lower St. Anthony Falls, which was

slightly lower. The primary reason that most calculated CIs were higher is that the experts based their overall gate rating on the lowest individual distress CIs, generally leak and corrosion CIs, without considering the other distresses.
